Fleet Support Conference 1,000 Hour Propeller Replacement

**Tom Whelan
Code R51**

05-07OCT04

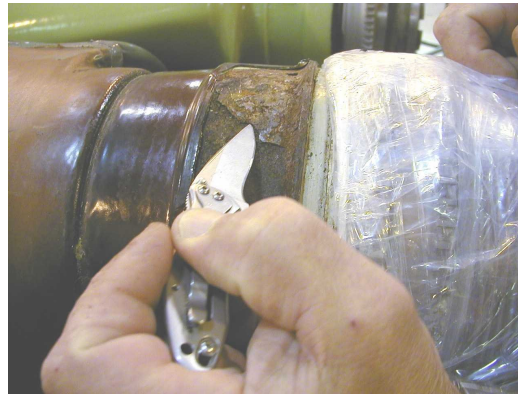
- Prop Blade Root Outer Sleeve Corrosion is yet another reason to replace LCAC propellers at 1,000 hours:

- Blades in this condition will be scrapped @ Depot
- Increasing failure trend will compounded by waivers
- Pending shortage in supply, Dowty reported @ work stop in repair queue
 - Present = No parts for 4 propeller assys
 - Near Future = No parts for 11 add'l propeller assys
 - FY05 Depot repair parts not ordered to date
- Need Blade Root Sleeve Corrosion Abatement Now
 - Recommend inspection of all blades > 500 hours (= 51 Props)
 - Remove corrosion / Re-Seal steel blade root
- Will impact LCAC Readiness
